PHASE II ENVIRONMENTAL SITE ASSESSMENT

**625 DOUGLAS STREET
WOODBURY COUNTY
SIOUX CITY, IOWA**

HR GREEN, INC. PROJECT NO. 210667

APRIL 6, 2023

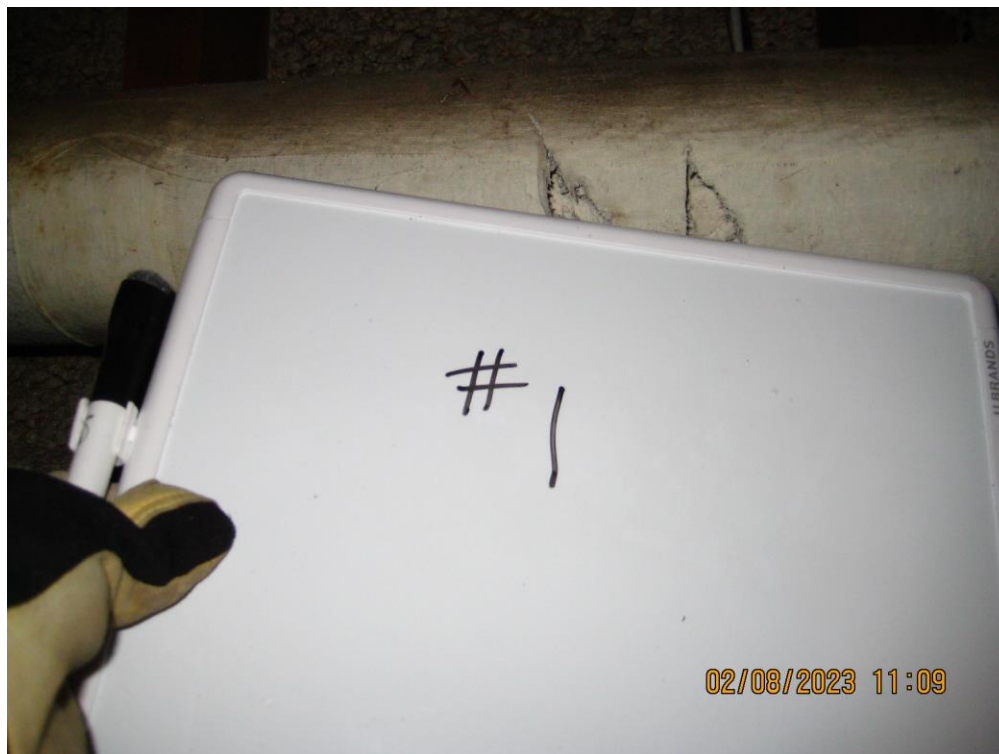
Sample #1 – Pipe Insulation (SE Basement Stairwell)

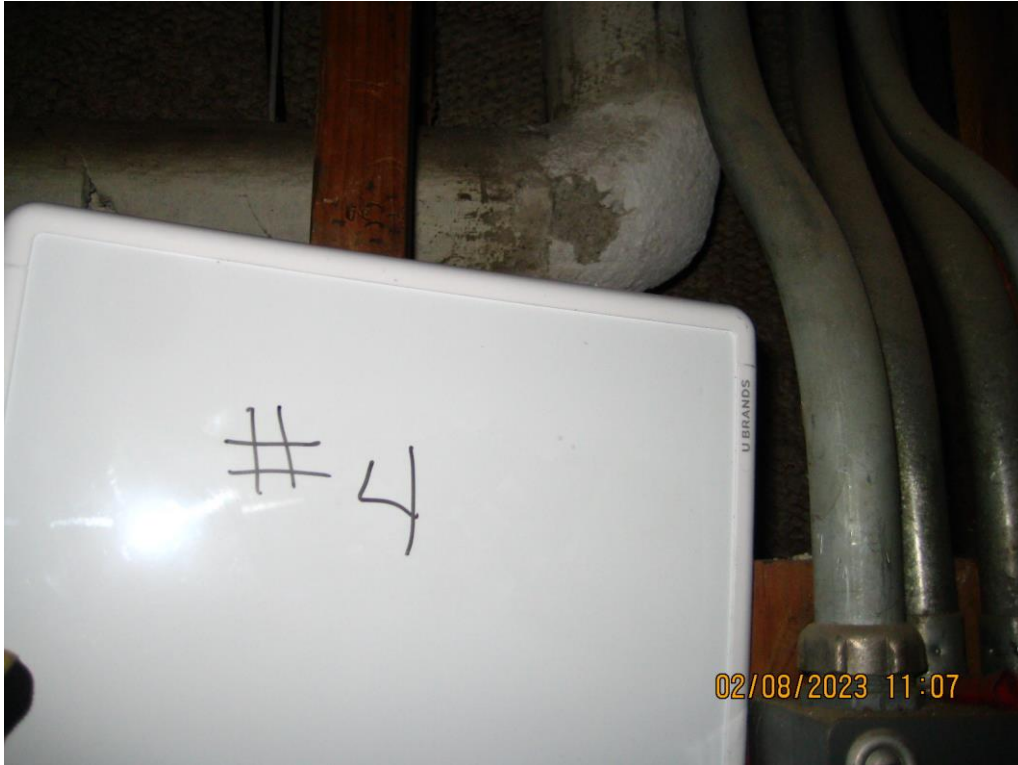
Sample #4 – Pipe Fitting (SE Basement Stairwell)
