SPECIFICATIONS PROPOSAL & BID DOCUMENT

IALHB0664-18 – 103
Property: 3430 6th Avenue

Sioux City, Iowa

JOB DESCRIPTION:
LBP Inspection / Risk Assessment
3430 6th Avenue
Sioux City, Iowa

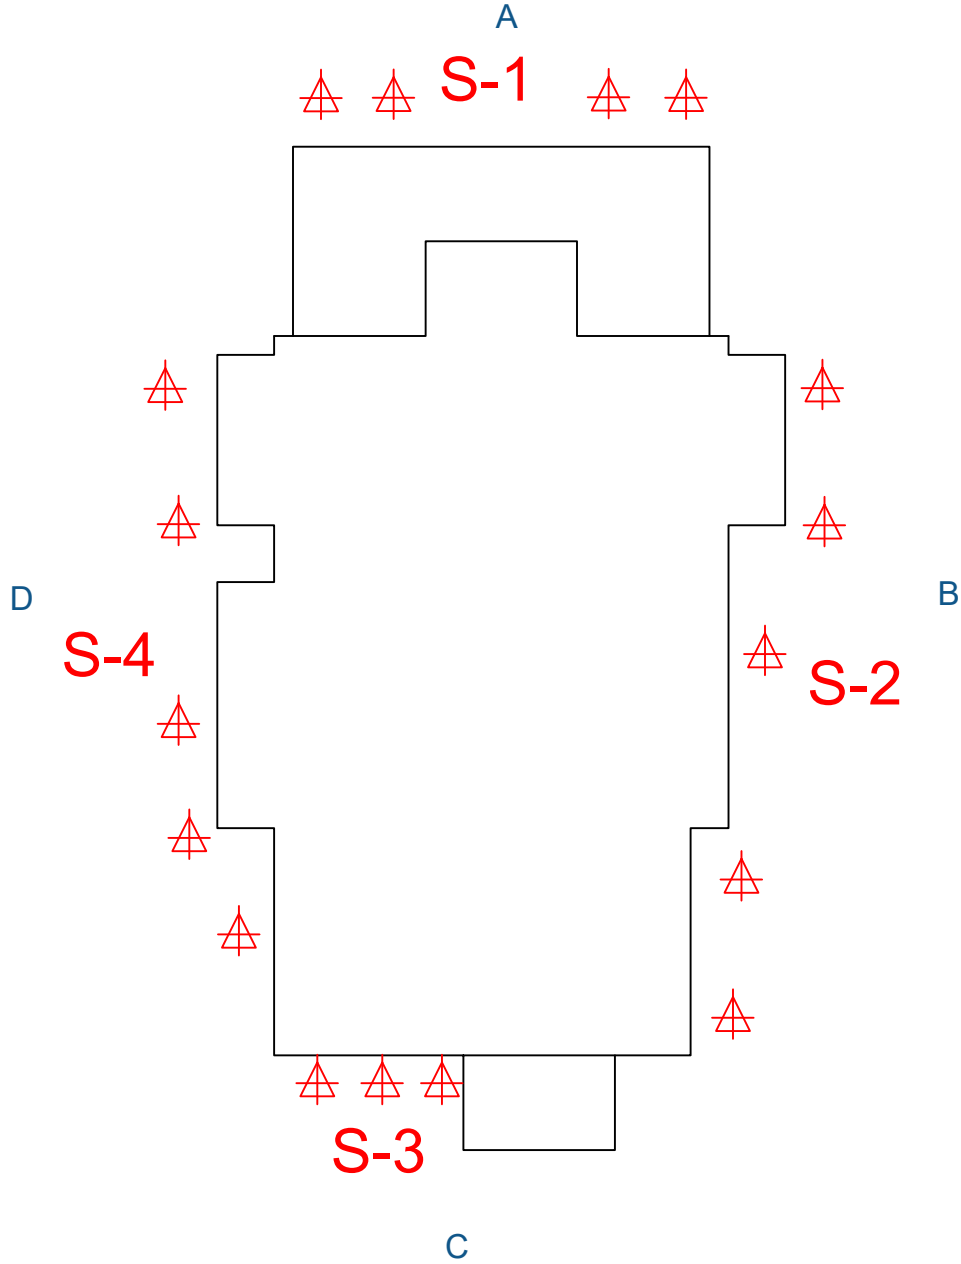
SHEET TITLE:
Property Map
Exterior

- ▲ Soil Sample
- × Dust Sample
- V = Vinyl
